Experimental and analytical investigation of dynamic crack patterns in automotive windshield sheets subjected to low velocity impact

P. Shojaei Shahmirzadi, H. Saeidi Googarchin*

Automotive Fluids and Structures Analysis Research Laboratory, School of Automotive Engineering, Iran University of Science and Technology, Tehran 16846-13114, Iran

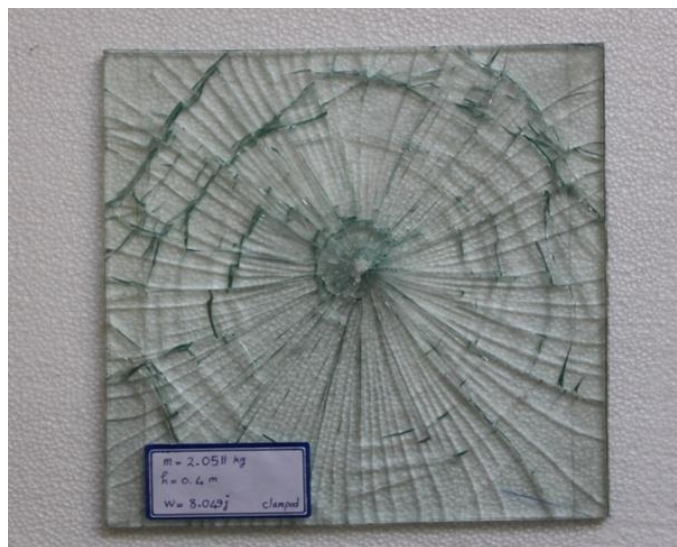
Fig10. .specimen after test code D-B-T-4

Laminated glass specimen after test code D-B-T-4 is shown in Fig.10.

As it is observed from Fig.10, the impact region at the center of specimen (powdering region) is a circle with approximate diameter of 20mm in which cracks density and consequently damage level is higher than the other regions of specimen. The projectile has penetrated to the depth of 1-1.5mm of the laminated glass and due to 2.5mm thickness of glass layers, no elongation has been occurred in PVB interlayer. Although energy level of test code D-B-T-4 is higher than test code D-B-T-3's one, penetration at the center of specimen is less in test code D-B-T-4 which

can be representative of impactor's mass influence. In test code D-B-T-4, the impactor mass is 2.0511kg, while it is 2.0712kg in test code D-B-T-3, therefore it can be concluded that in 2 similar conditions, the less impactor mass, the less penetration depth at the center of specimen.

It is easily seen from test code D-B-T-4 specimen that cracks have initiated from the impact surface and propagated through thickness. In this test, one circumferential crack has been propagated which is at the radius of 95mm from the center. Besides, some sectors of circumferential cracks have been made at the

radiuses of 62, 70 and 80mm from the center of specimen and serve as bridges to connect radial cracks. Also it can be seen from the laminated glass that the radial cracks in test code D-B-T-4 are nearly symmetrical and about 84. After drawing a comparison between test code D-B-T-4 and test code D-B-T-3, it is obvious that radial cracks of test code D-B-T-4 are more than their counterparts in test code test code D-B-T-3, on the other hand circumferential cracks of test code D-B-T-3 are more than test code D-B-T-3's ones. At test code D-B-T-4, distance between radial cracks is shorter than its corresponding item in test code D-B-T-3.

At all 4 sides of specimen which was clamped during the test, diagonal asymmetrical

net shaped cracks have been made which have created some right triangles in margins of the specimen. Diagonal net shaped cracks at the margins of test code D-B-T-4 specimen are more congested in comparison to the whole radial cracks. In addition, at both upper and lower glass layers, radial cracks converge at the center of the specimen and their divergence increases at larger radiuses. The acceleration versus time graph of test code D-B-T-3 is illustrated in Fig.11. As it can be seen from the graph, the maximum acceleration imposed to projectile is 732.0356m/s^2 which is occurred at 0.000131s .
