Study of the effect on manufacturing parameters on the fatigue behavior of aluminum engine mounting bracket

Hossein Khalajzadeh¹, Seyed Vahid Hosseini^{*1}, Alireza Shaterzadeh¹

¹Faculty of Mechanical Engineering, Shahrood University of Technology, Shahrood, Iran.

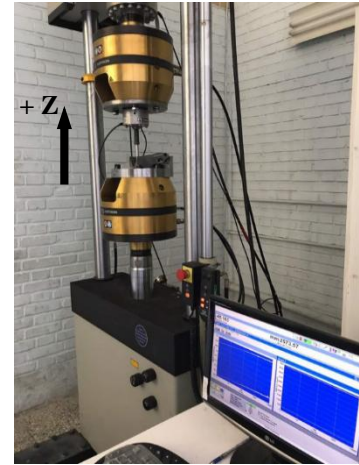
Since the engine mounting bracket plays an essential role in the car, it must be designed and built in such a way that it has high fatigue resistance. In order to assess the fatigue life of the engine mounting bracket, it is imperative to conduct fatigue tests along the Z axis direction [22]. The initial measure, with the purpose of positioning the engine mounting bracket appropriately with repeatability and securing the engine mounting bracket throughout the test, is required. Therefore, the fixture was designed according to the geometry of the part and the requirements of the test. VCN 150 was used to make the main body of the fixture to perform the test in the Z direction due to its good strength, rust resistance and initial hardness of about 35 Rockwell C. The dimensions of the fixture are designed and built according to the dimensions of the device and the work piece. Subsequently, the fatigue test was conducted on the engine mounting bracket employing an Instron 8802 hydraulic servo machine proudly manufactured in England, possessing a remarkable capacity of 250 kN. The dynamometer sensor used is 25 kN manufactured by Instron, which is shown in Figure 1.

Figure 1. Fatigue test with Instron machine in Z direction.

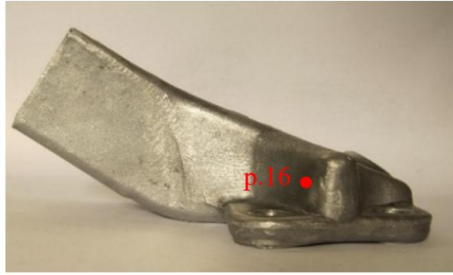
In order to investigate the reasons for the failure of the prototype in the external shell, a 3D scan was prepared by an optical device made by the Spanish company Nub 3D with a 1.5-megapixel camera lens. Also, the obtained data was entered in the SolidWorks software for the purpose of 3D modeling, which is shown in Figure 7. Finally, with the investigation, it was found that the outer shell of the initially produced part matches with the main designer of the part, so the outer shell of the part cannot be the cause of failure. After examining the outer shell, the thickness of the wall of the produced part was examined by the ultrasonic device made by the American company Olympus, model 38DL-Plus. After obtaining the thickness of the produced part, it was found that in some parts of the wall, such as point 16, the ultrasonic device shows less thickness, but referring to the reports after the test, no cracks were observed in these parts. As shown in Figure 8, the low thickness in these parts cannot be the reason for failure in the part.

Figure 8. a) Ultrasonic thickness measurement. b) The graph obtained from the thickness measurement results of the prototype. c) Location of point 16 (Minimum thickness).
