Study of the effect on manufacturing parameters on the fatigue behavior of aluminum engine mounting bracket

The engine mounting bracket connects the engine to the car body and plays a key role in reducing vibrations and supporting the engine's weight and dynamic loads. It must be designed to withstand cyclic forces during normal use but fail safely in high-impact situations, like accidents, to minimize damage. This study examines how manufacturing parameters affect the fatigue performance of aluminum engine mounting brackets in cars. According to the staircase-Locati fatigue test results, the relative mean resistance load was measured at 1.24 with a relative scatter of 0.07, placing it in the unsafe operating region for the engine mounting bracket. To address this, a finite element analysis was carried out to identify critical areas on the part and implement modifications to enhance its performance. The crack initiation and growth regions observed during the fatigue tests aligned closely with the critical zones identified in the finite element analysis. Following the modifications and the removal of production defects, a series of experimental tests were conducted to assess the en

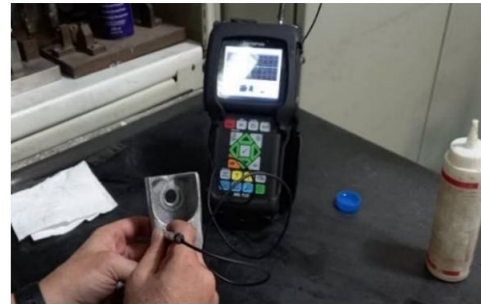
Figure 8. a) Ultrasonic thickness measurement. b) The graph obtained from the thickness measurement results of the prototype. c) Location of point 16 (Minimum thickness).
