## Study of the effect on manufacturing parameters on the fatigue behavior of aluminum engine mounting bracket

Hossein Khalajzadeh<sup>1</sup>, Seyed Vahid Hosseini<sup>\*1</sup>, Alireza Shaterzadeh<sup>1</sup>

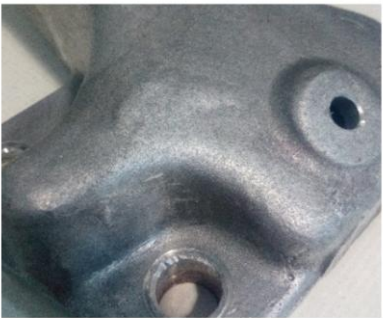
The reinforcement of the connection area of the base to the wall in the modified sample has led to the removal of the crack in this area. In order to make a more detailed investigation, after the completion of the fatigue test, a comparison of the primary and secondary samples was made by conducting a penetrating liquid test. Also, after fixing the manufacturing parameters to cause the cracks in the part, by repeating the high-cycle fatigue test on the modified sample, the crack moved from the connection area of the base to the wall to the end area of the part, as shown in Figure 11. This means that similar to the finite element results in the modified sample, the most critical region is located at point A. Table 9 shows the improvement of the modified sample respected to primary sample. As observed, the resistance of modified sample increased by 7% and scatter of fatigue results has decreased by 14%.

**Figure 11.** a) Identification of the crack in the front area of the primary sample. b) Removal of the crack in the front area of the modified sample. c) Appearance of a crack in the end area of the modified sample.
